# Investigation Summary: Perchlorate Contamination in Yaphank, Suffolk County, NY

January 2001

Suffolk County Department of Health Services  
Clare B. Bradley, M.D., M.P.H.  
Commissioner

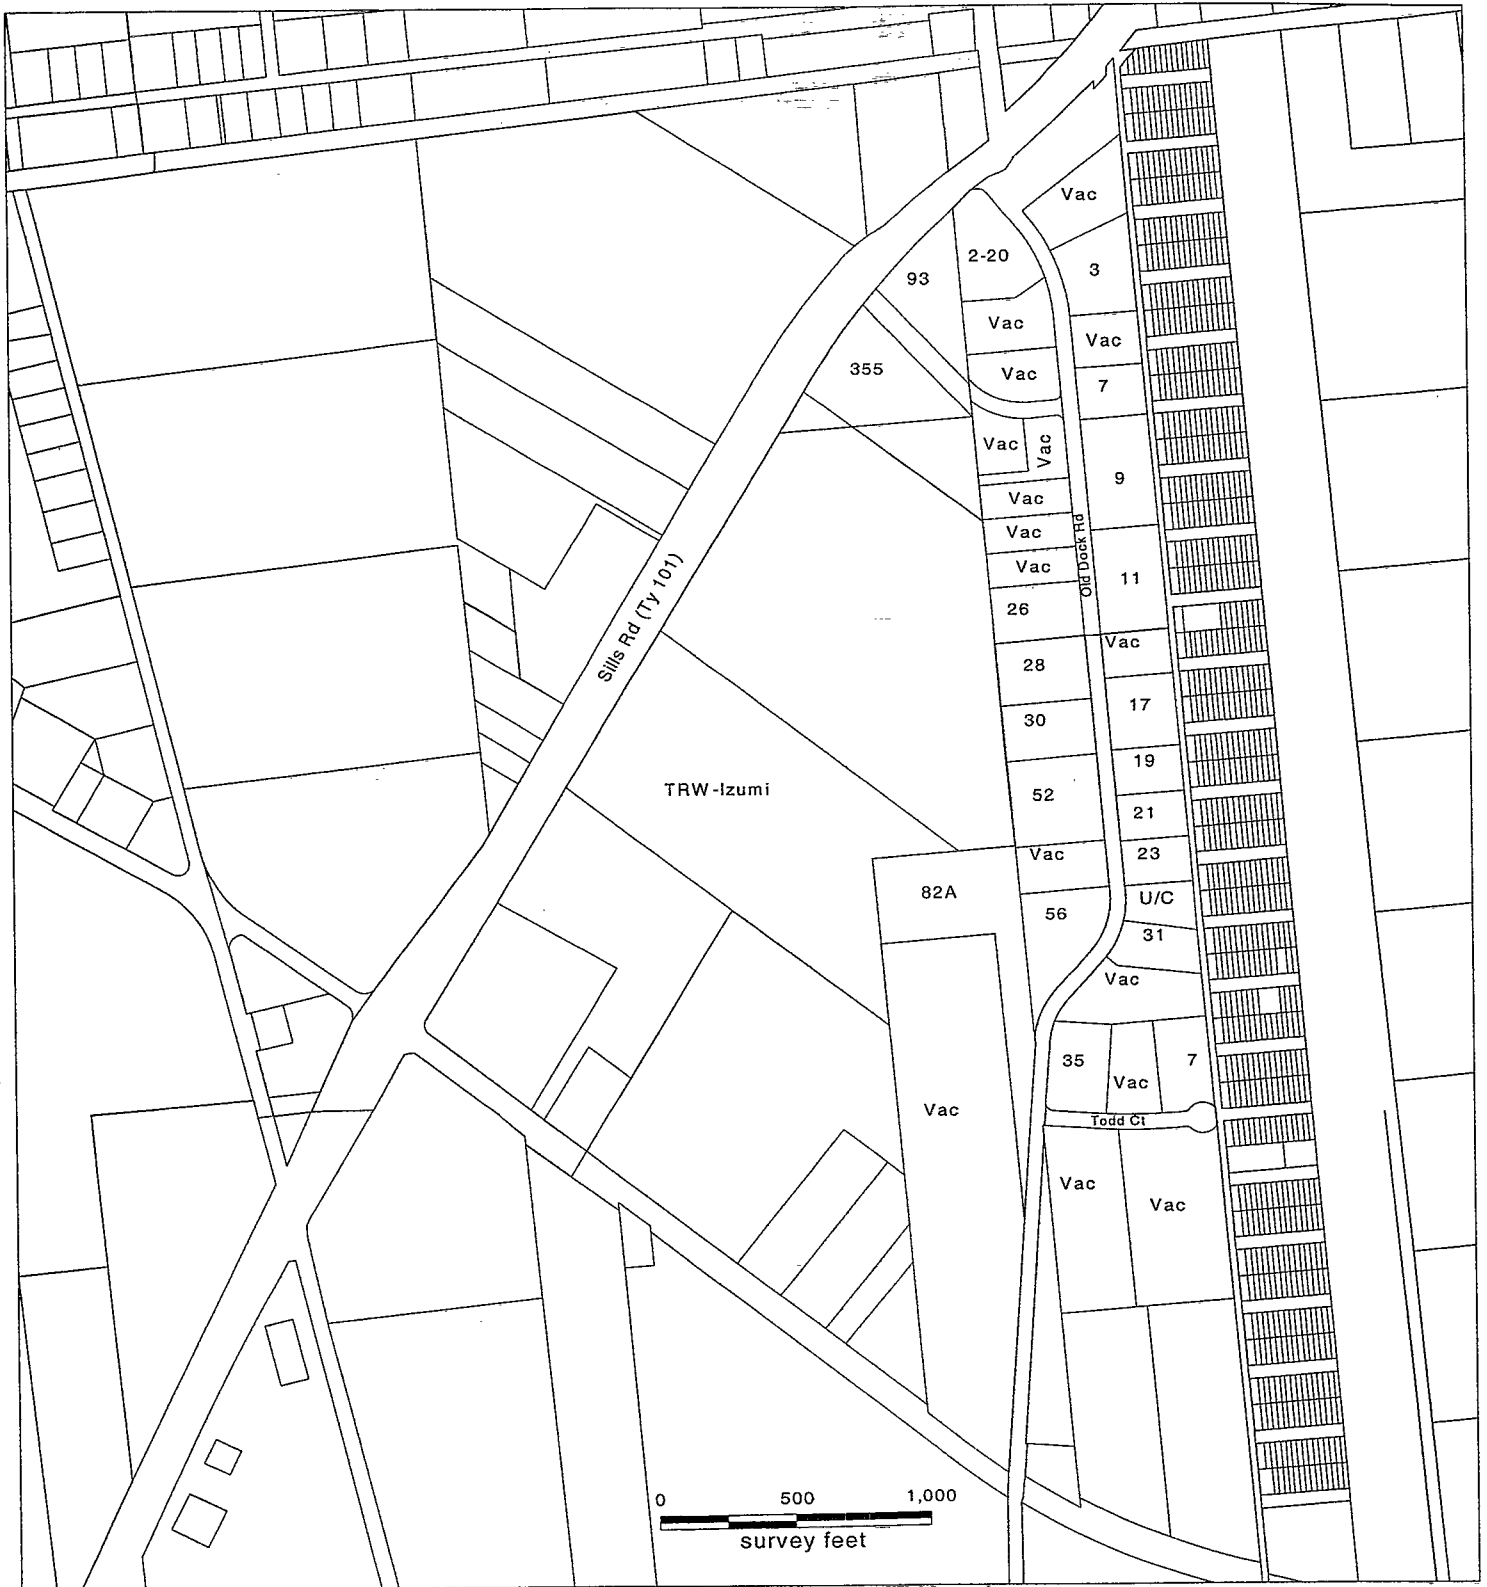
**FACILITY INSPECTION LOCATIONS**

The Office of Pollution Control conducted an extensive investigation of industrial sites upgradient of the contaminated wells. Between August 11<sup>th</sup> and September 12<sup>th</sup> of this year, 36 industries were inspected along Old Dock Road, Todd Court and Sills Road in Yaphank.

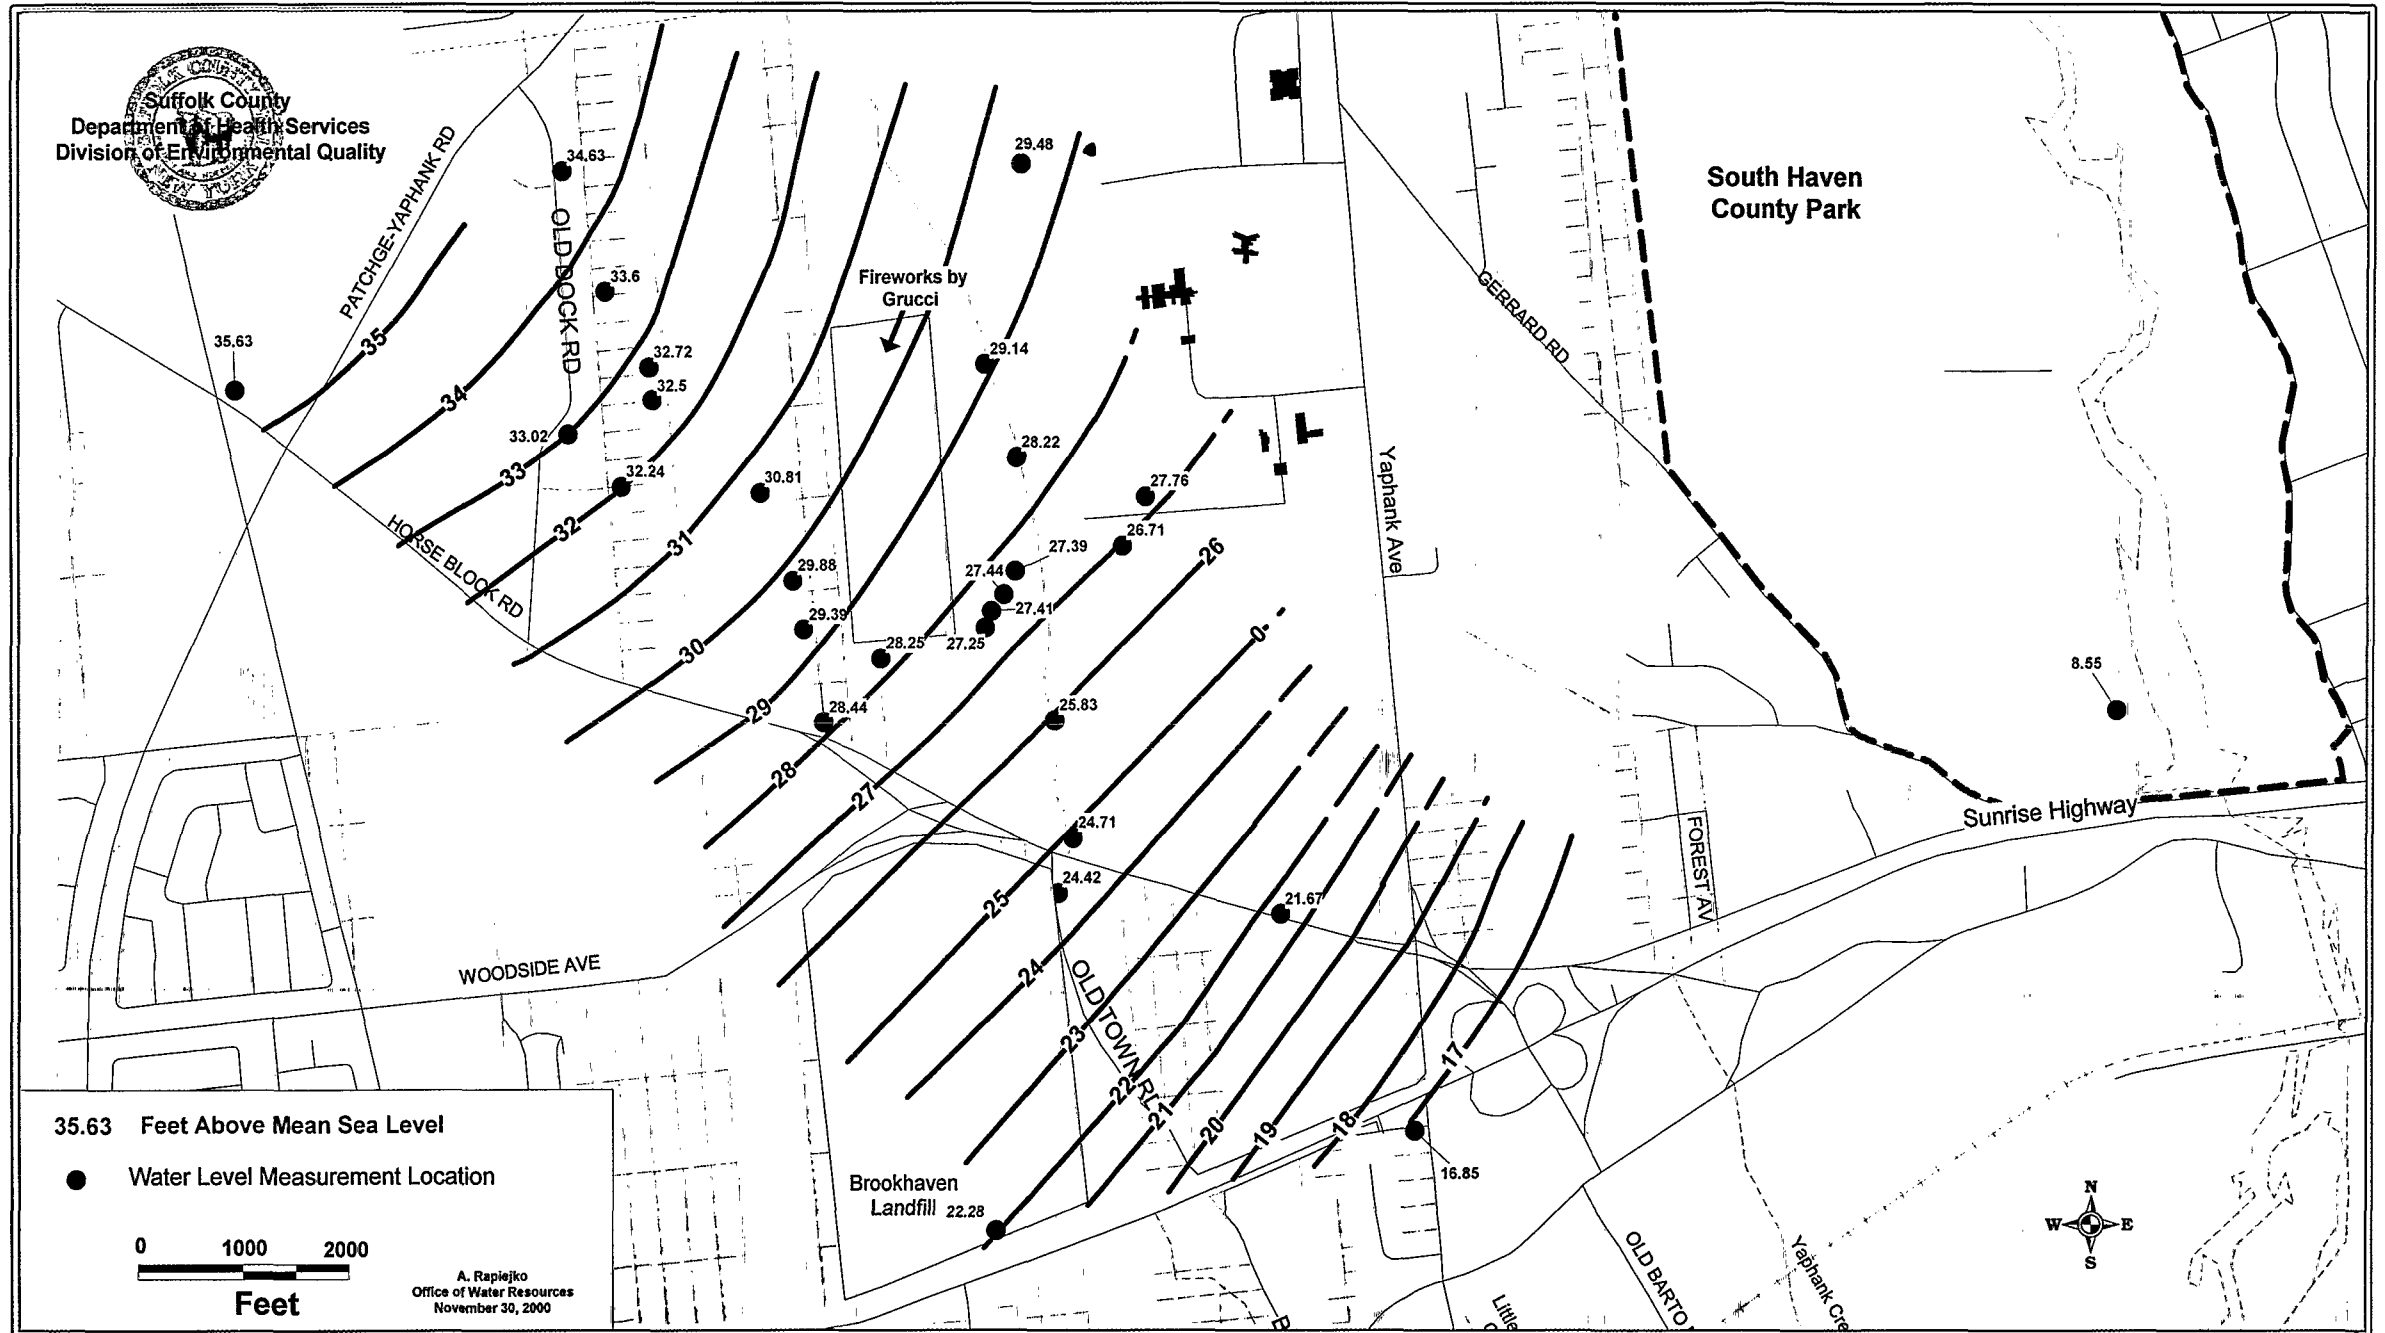
# Plate 2 Water Table Contours

In order to conclusively determine groundwater flow direction, all 24 monitoring wells installed by SCDHS were surveyed to establish elevations. A new round of synoptic water levels was taken at the monitoring wells, and also at 10 pre-existing wells, in the area bounded by Sills Road on the west to Yaphank Avenue on the east. The water table measurements are plotted on Plate 2 - Water Table Contours, and the final groundwater contours interpolated from this data set of elevations are also shown on the Yaphank Perchlorate Investigation Plate 1. The contours definitively establish the direction of groundwater flow to the southeast.

1. Local groundwater flow direction to the southeast was conclusively determined by twice measuring water table elevations at multiple wells. The flow direction established is consistent with several past groundwater investigations conducted in the area.
